# 2017 INFINITI QX70 AWD

#### **VIN # JN8CS1MW1HM414702**

INSPECTION DATE: FEBRUARY 28, 2025 @ 16:41

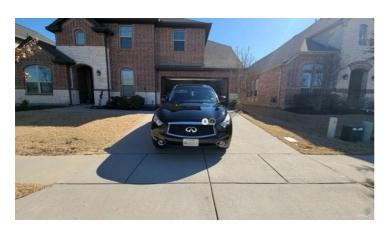
### FRONT SIDE

COMPONENT	CROPPED PHOTO	DAMAGE TYPE	SEVERITY	REPAIR METHOD
5 Front Bumper Cover		Has Medium Dent - Not Through Paint	> 3 inches	Repair & Refinish
